Marine Surveying

– It's benefits to
Commercial Shipping &
your Company's bottom line

CAPT. ZARIR S. IRANI,

ICS ME SILVER JUBILEE CPD WEBINAR SERIES

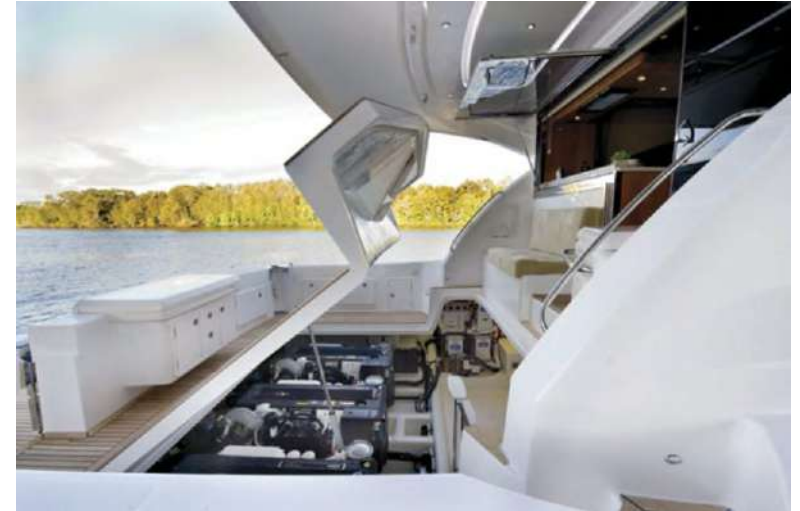
- The engine was already in a dismantled condition at the time of survey. (2 hours turn around post nomination)
- There was an appearance of a whitish colours to the remnants of the lube oil present in the engine casing.
- Investigation revealed that there was a hole in the gasket.
- Further investigation revealed that there were burn marks on the cylinder head.

- We were to put evidence that the cause of engine seizure was due to following tell-tale factors :
 1. There are burnt marks on the cylinder head.
 2. There was a hole in the cylinder head gasket caused by overheating.

3. As a result of hole in the gasket the cooling water mixed with lubricant oil affecting its lubricity, causing the engine to seize.
- A mere act of propeller getting entangled in a HARD rope (rope is not normally hard) would have stopped the engine (but not caused seizing of the engine). In depth knowledge & deeper investigation of facts and tell tails payed its rewards.

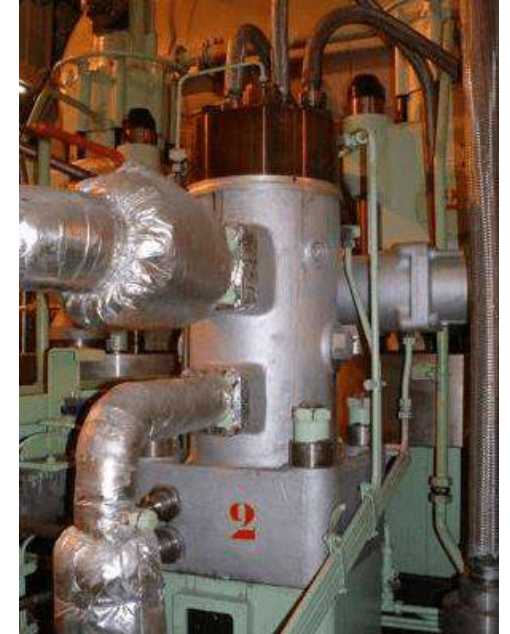
Fact: 12 Nos. plunger and barrels of the fuel pump of the Auxiliary engines belonging to a ship had seized. 8 Nos plunger and barrels of the fuel pump of the Main engine had also seized. There was sludging of the fuel evident.

- The plunger and barrels of fuel pumps of both Main engines and Auxiliary engines were worn out and sticking. The chrome polish on the plunger had vanished.

- Our investigation led us to the lab analysis report which indicated that the fuel which was tested as per ISO standards, apparently seems to have been met the specification of the fuel. The fuel which was the cause of the above problem was supplied by charterers .We were able to put the charterers in a defending position.
- We were able to put forward the comingling issues between two bunker fuels. The heavy oil settling and service tanks are to be emptied and cleaned before letting a new parcel of bunker fuel. The above has not been proved nor documented by the owners. As known as, comingling issues can cause sludging of the fuel.

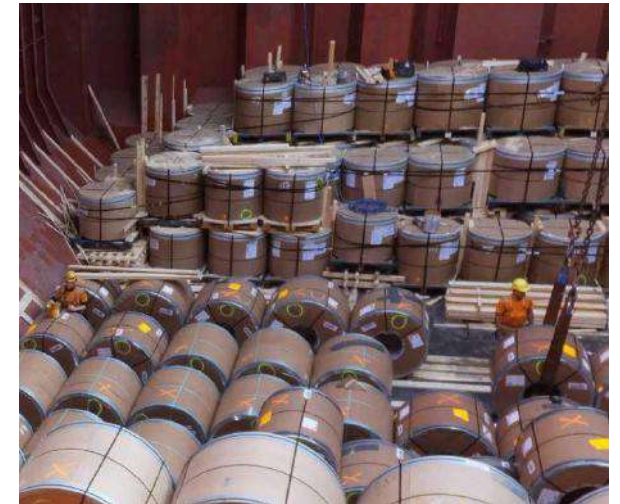
Fact : *Surveyor was nominated to attend a joint survey to investigate cargo appearing in rusty condition.*

- The attending surveyor had checked the shipping marks stipulated on the cargo with the packing list and Bill of Lading. (Which indicated clean cargo – free of rust).
- Silver Nitrate test was carried out at 10% random basis on the rust affected cargo and was found that there was no salinity on the cargo. Further investigated on this matter and it was proven that few days ago there was heavy rain fall (As per the weather reports), and all the cargo which they stored in their open yard and was completely affected by the water rain.

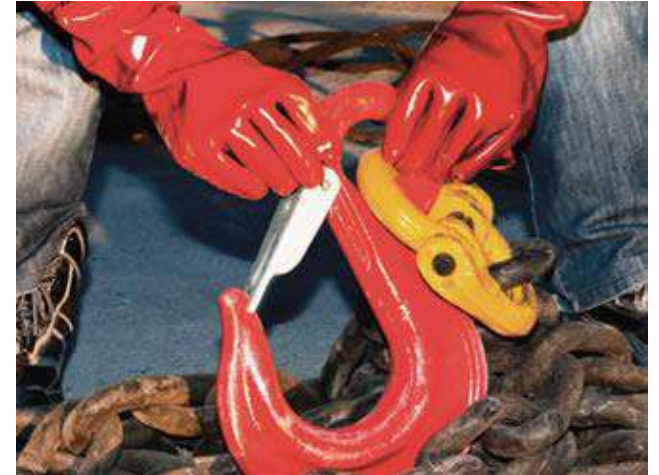
- Condition inspection of each gears with identification marks.
- Checking of operating condition of each gears
- Inspection of load test certificate
- Bridle wire of the barge was seen rusted with lack of greasing (effected immediately)
- Strands of steel was broken which could have reduced the actual SWL of the wire
- The damaged wire was replaced with new spare wire

- The broken strands bridle wire if not replaced it would have parted during the loaded tow voyage and , may have damaged own and other vessel or ports property resulting in avoidable claims.
- If the loose gear was inspected timely the spread, could be rejected for towing and delay charges from port would become to the owners /account
